Learning from Slope Failures in Hong Kong

H. N. Wong & K. K. S. Ho

Geotechnical Engineering Office, Civil Engineering Department, Hong Kong

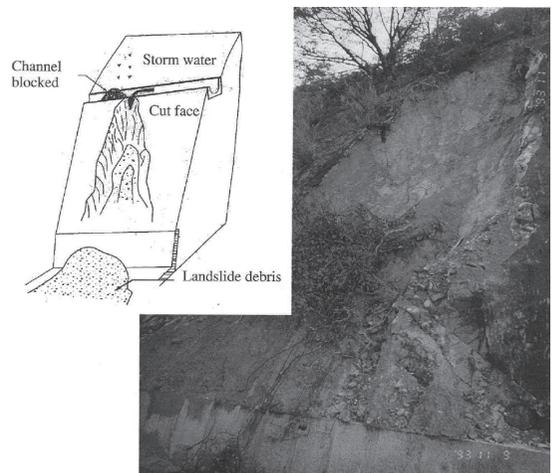
Inadequate maintenance generally takes the form of blocked or disrupted drainage channels, damaged hard surface cover (e.g. shotcrete), or poorly maintained vegetation. Many of the landslides involved washout failure due to overspill from blocked or damaged crest drains (Figure 5), infiltration into oversteep slopes through bare or poorly maintained vegetated ground or cracked surface protective cover, build-up of water pressure behind hard surface cover with blocked weepholes, or leakage from poorly maintained

Figure 5. Washout failure due to overspilling from blocked crest drain

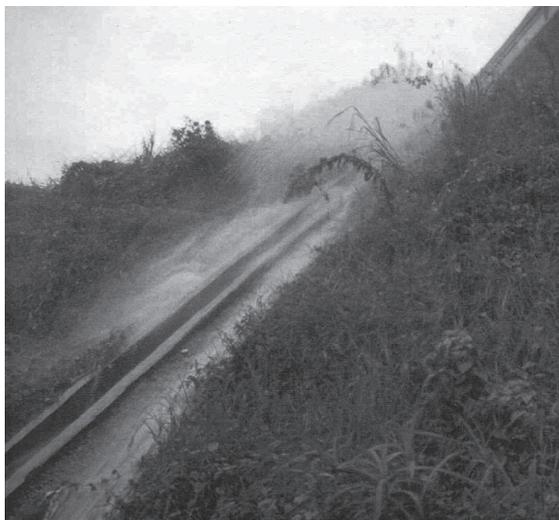
Inadequate attention to proper detailing may involve drainage channels that are undersized or with inadequate fall for self-flushing and hence are vulnerable to blockage, drainage detailing which is prone to over-spilling, etc. (Figure 6). Sometimes, surface water flow or ponding due to the adverse site setting or topography (e.g. slopes below the low point of a crest platform or a road bend can be subjected to concentration of surface water flow during intense rain) are not properly addressed in the design (Figure 7). The identification of surface water flow paths requires tracking all the possible pathways outside the immediate site environs since the sources of surface water concentration may be at a considerable distance away from the site. However, studies of landslides have revealed that the assessment may not have been done properly in practice.

Figure 6. Over-spilling due to inadequate surface drainage detailing

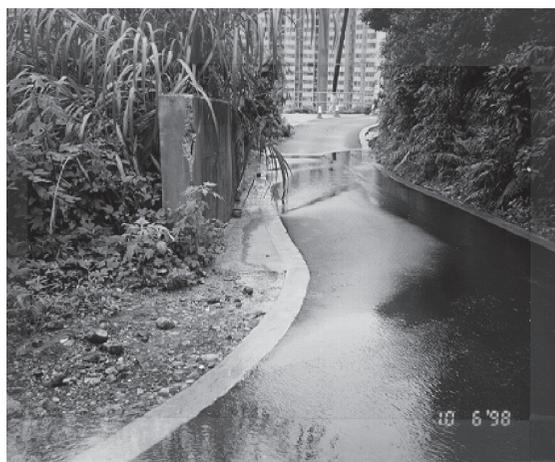
Figure 7. Ponding due to poor surface drainage provision

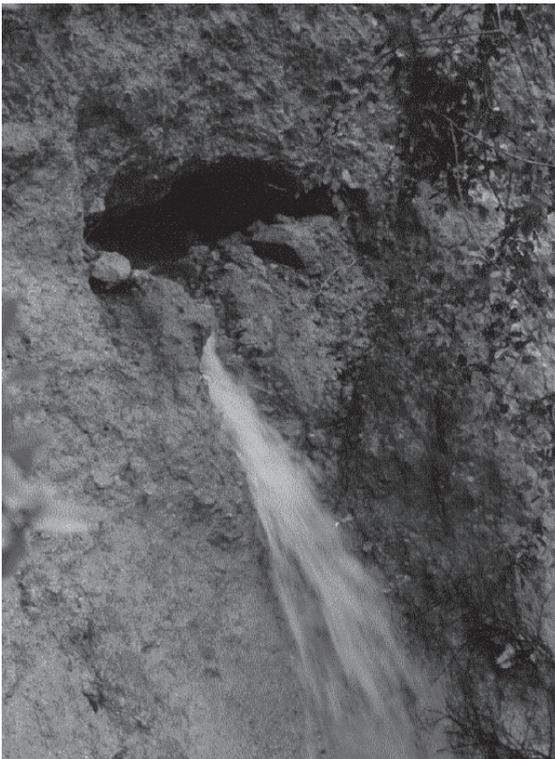
Figure 8. Erosion pipe with heavy seepage

One common cause of failure involves a shallow perching phenomenon. This can occur where there is a surface layer of thin colluvium overlying less permeable saprolite. Perching is also possible at the interface of loose (younger) colluvium and dense (older) colluvium. Loose colluvium can be prone to the formation of erosion pipes which act as conduits resulting in rapid rise in groundwater pressure during heavy rainfall (Figure 8). The geometry of the failure

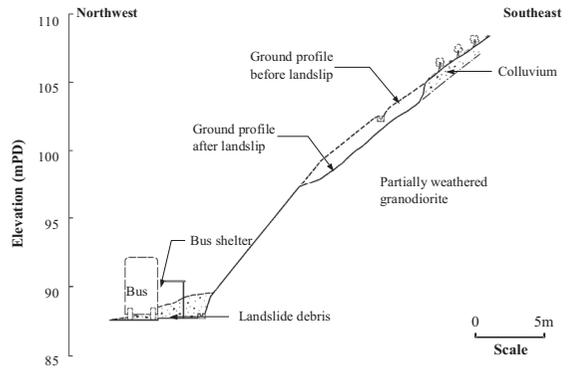
Figure 9. Cross-section of the 1993 Cheung Shan landslide

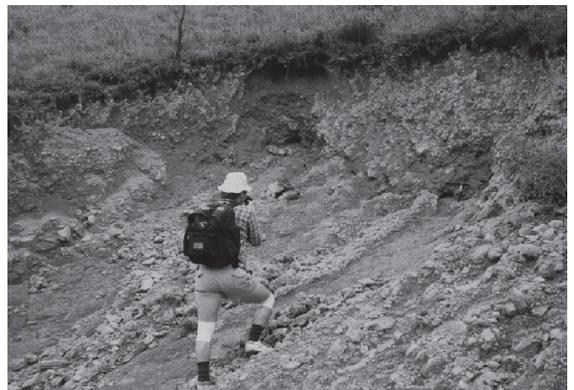
scar associated with the above adverse hydrogeological setting is typically confined to the shallow depths within the upper portion of a cut face and can extend uphill for some distance. Because of this, such failure mode can result in serious consequences in the case of a high cut slope, even though the scale of failure may be small. To illustrate such failure mode, a cross section through the 1993 Cheung Shan landslide is shown in Figure 9. In the study of more than 250 failures of cut slopes along roads and catchwater caused by a severe rainstorm in November 1993, Wong & Ho (1995) reported that up to about 25% of the failures involved a perched water table in the surface mantle of colluvium (Figure 10).

Figure 10. Failure involving surface mantle of colluvium

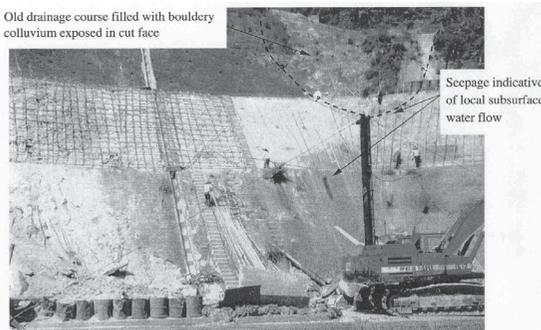
Figure 12. Old drainage course with subsurface water concentration (This processed slope failed in 1997)

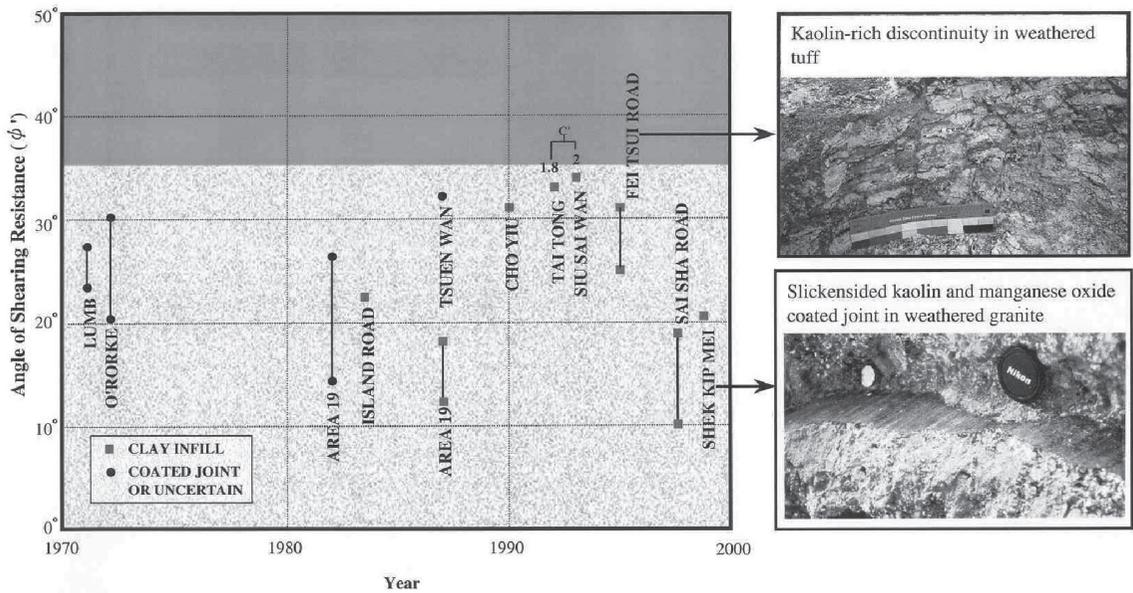
Figure 13. Selected landslides involving relict-jointed saprolite

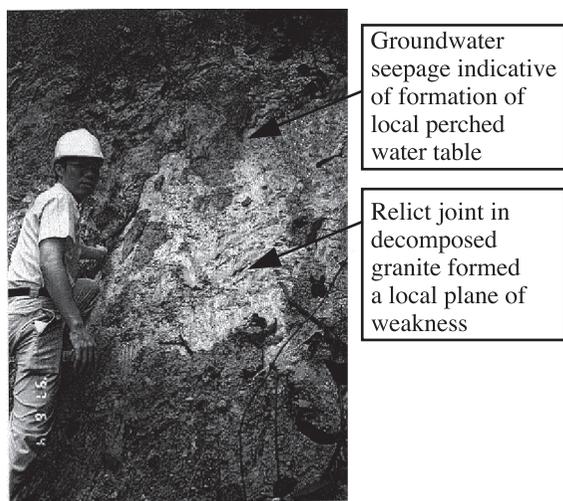
About 70% of the landslides at engineered soil cut slopes were small scale failures controlled mainly by the local geological and/or groundwater conditions (Figure 14). This gives an indication of the annual defect rate (about 0.15%) associated with such localised failures given the current state-of-practice in Hong Kong.

Figure 14. Landslide controlled by local adverse geological and hydrogeological conditions

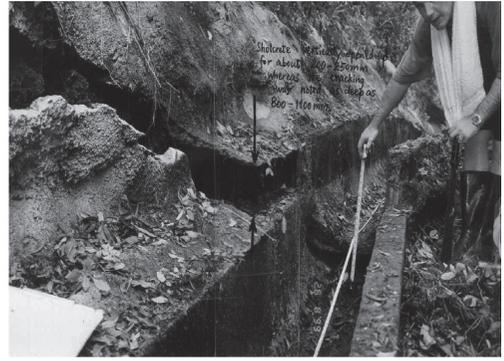
Figure 15. Infilled tension crack

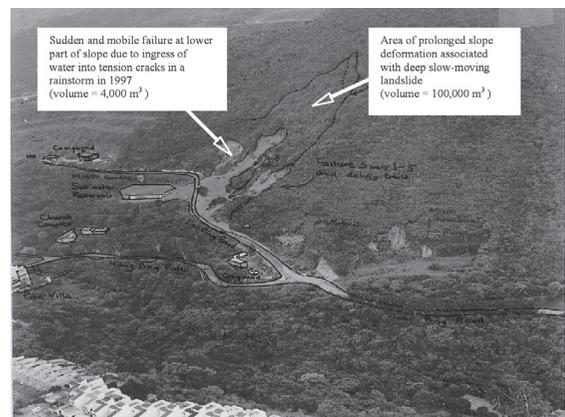
A scenario that is of particular concern and great practical significance is where an apparently ductile failure with limited mobility turns into a brittle, mobile failure with fast-moving debris. There are reported landslides in Hong Kong which exhibit an apparent change in failure mechanism, e.g. the 1997 Lai Ping Road landslide as shown in Figure 18 (Sun & Campbell, 1999). This is usually related to the

progressive deterioration of the distressed ground which promotes increased water ingress and brings about detachment of material, possibly via a different mechanism (e.g. cleft water pressure) than that operating in the slow-moving ground mass.

Figure 18. The 1997 Lai Ping Road landslide

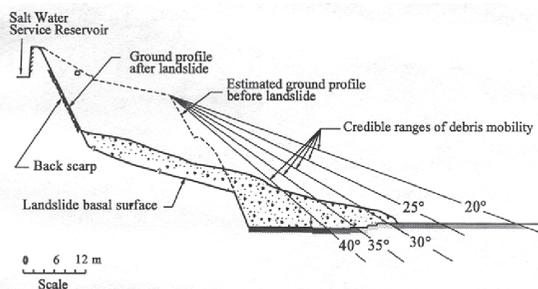
The second example concerns a site-specific QRA. The generalized consequence model was used to back-analyse the Fei Tsui Road landslide, which occurred in the early hours of 13 August 1995 with a failure volume of some 14,000 m³. The road in front of the slope was totally engulfed by landslide debris of up to about 6 m thick (Figure 20). The incident resulted in one fatality and one other person narrowly escaped injury. The theoretical consequence model predicts an average number of four fatalities arising from the given landslide. This illustrates the near-miss nature of the incident with only one fatality. The f-N curve derived from QRA calculations (Figure 21) shows the level of societal risk posed to the community by the Fei Tsui Road landslide.

Figure 20. Cross-section through the 1995 Fei Tsui Road landslide
