寶雲道
斜坡研習徑

寶雲道 Bowen Road Slope Study Trail

土木工程拓展署轄下土力工程處於寶雲道設立了「寶雲道斜坡研習徑」，讓老師、學生和市民沿途自助導覽各種香港常見的斜坡工程。研習徑由寶雲道臨時休憩處開始，途經寶雲道健身徑，終點是司徒拔道。研習徑路程約3公里，需時約1小時。途中設有多個研習點，介紹附近的特色斜坡工程，包括各類防止及防治山泥傾瀉和斜坡美化措施。

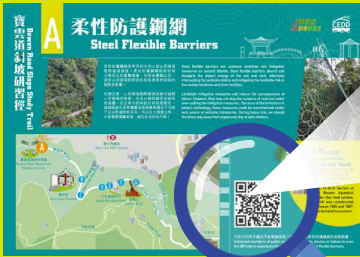
研習點資訊板
Information boards at study points

我們利用虛擬實境的技術，把斜坡工程的虛擬動畫展現在實境當中。市民可以利用手機或平板電腦掃描研習點資訊板上的二維碼進行體驗：
We use Virtual Reality (VR) technology to visualize the virtual animation of slope works in real environment. Interested members of the public can experience it by scanning the QR codes on information boards at the use of their mobile phones or tablets:

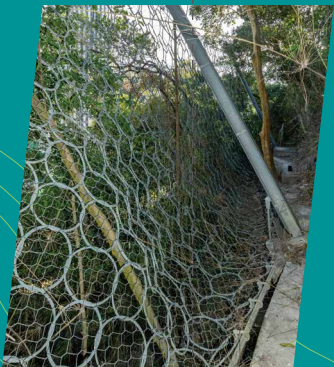
A 柔性防護鋼網

Steel Flexible Barriers

柔性防護鋼網是常見的天然山坡山泥傾瀉風險緩減措施。柔性防護鋼網能吸收和分散泥石的撞擊能量，有效地攔截山泥，減低山泥傾瀉對附近民居或者其他設施的風險及影響。

Steel flexible barriers are common landslide risk mitigation measures on natural hillside. Steel flexible barriers absorb and dissipate the impact energy of the soil and rock, effectively intercepting the landslide debris and mitigating the landslide risk to the nearby residents and other facilities.
